Gasparilla Island Bridge Authority

Design Update for the South and Center Bridges
Public Information Workshop
December 7, 2010

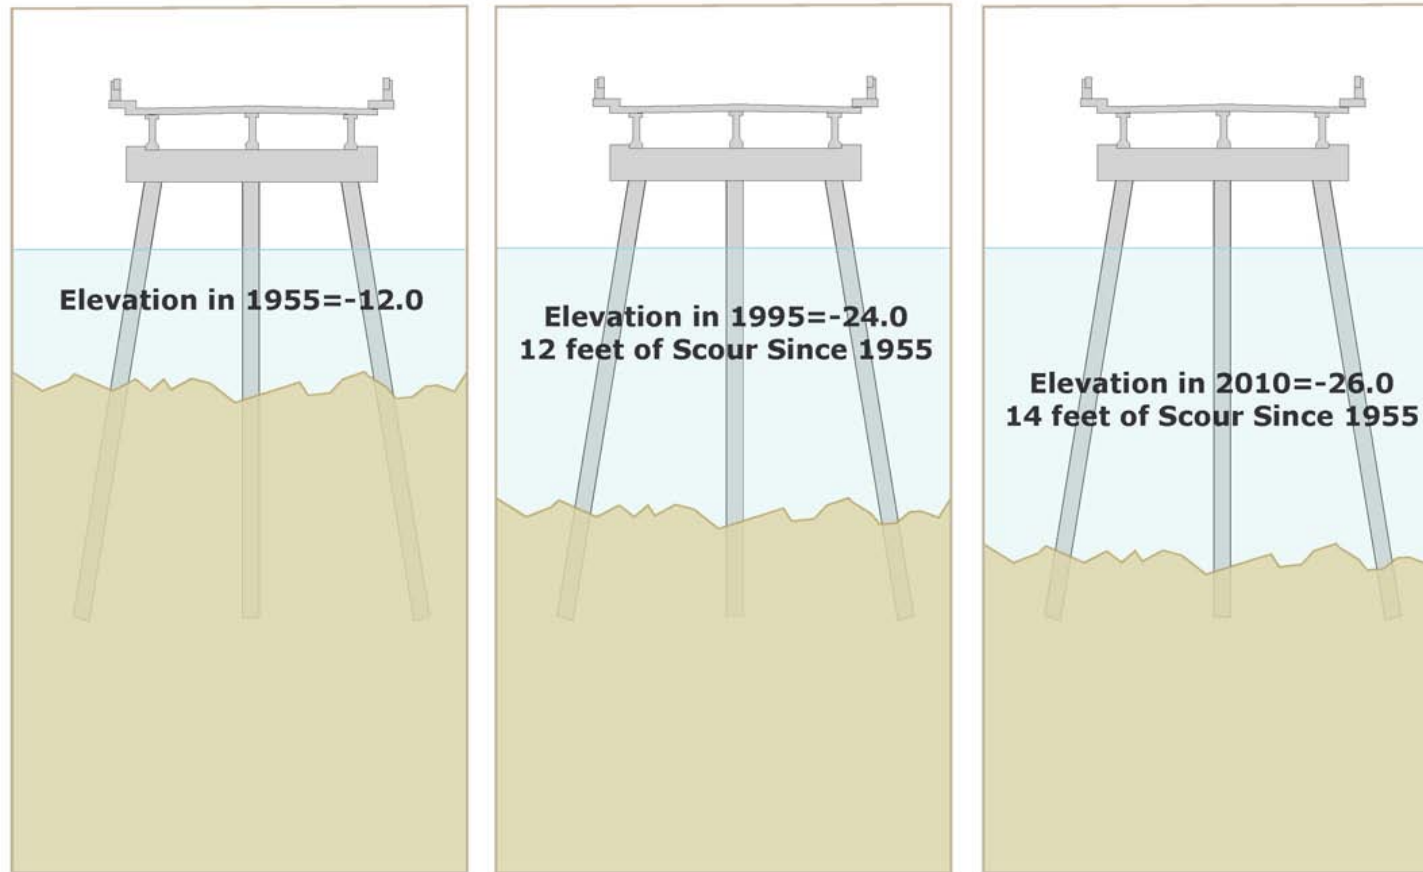
Bridge Scour History

1955

1995

2010

- **2005** Finish tests including additional soil borings, salt intrusion tests and studies of bridge's load capacities
 - South bridge *most critical* in storm surge situation, pilings least embedded in bay bottom
 - Currents removed 10 ft. of soil since bridge built
 - **Conclusion: All GIBA bridges need replacement in 7-15 years from 2005**
- **2010** Reduced speed limit to 20 MPH, installed speed bumps to reduce stress on the fixed bridges

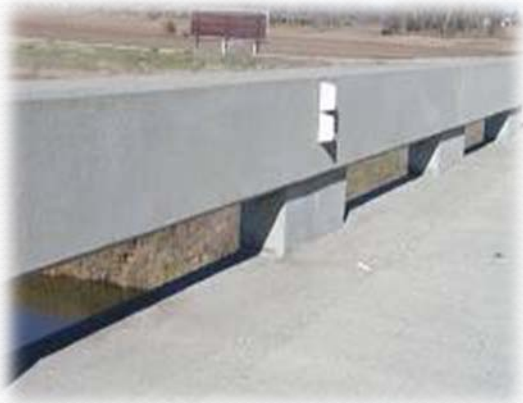
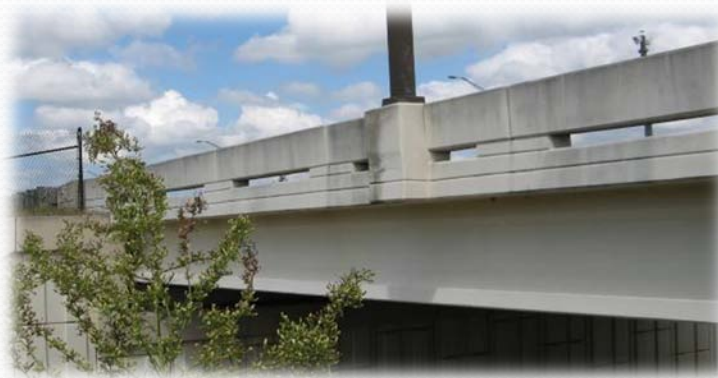
**Standard FDOT
Corral Shaped
Barrier**

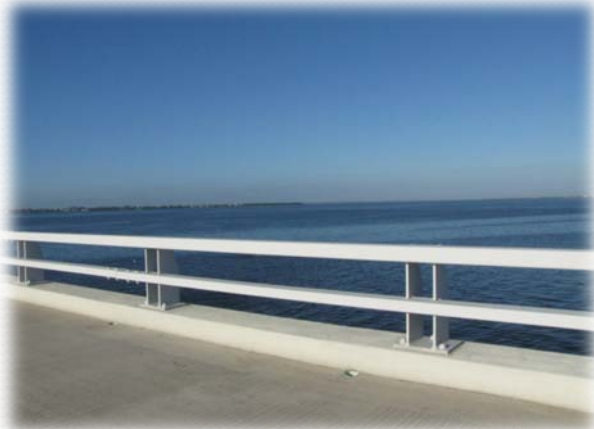
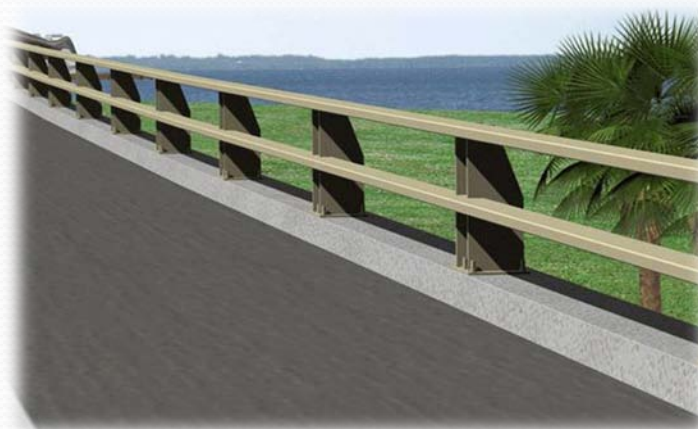
**Proposed
Wyoming 2-Tube
Railing**

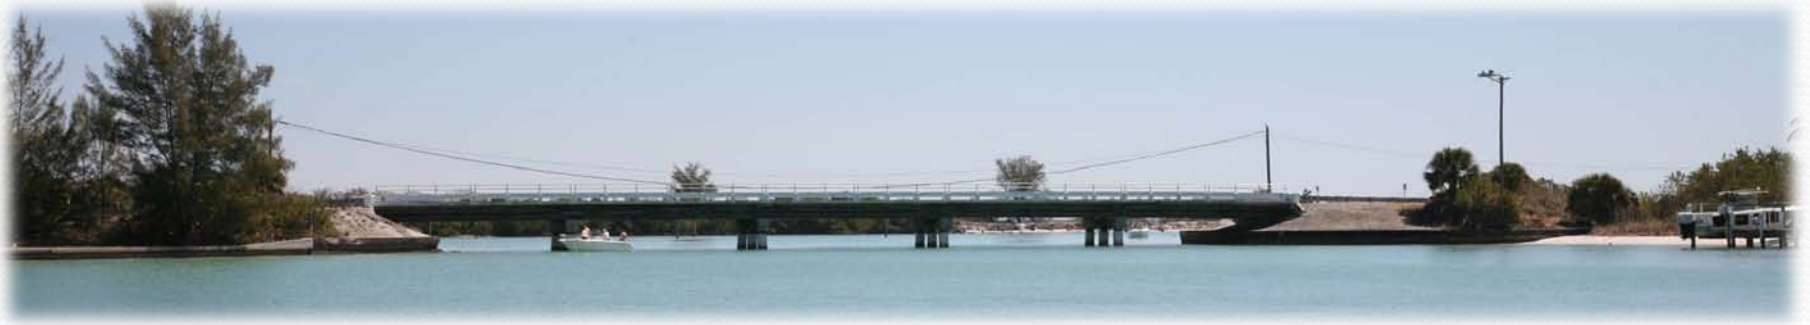
South Bridge – Existing and Proposed

Existing vertical clearance = 7 feet

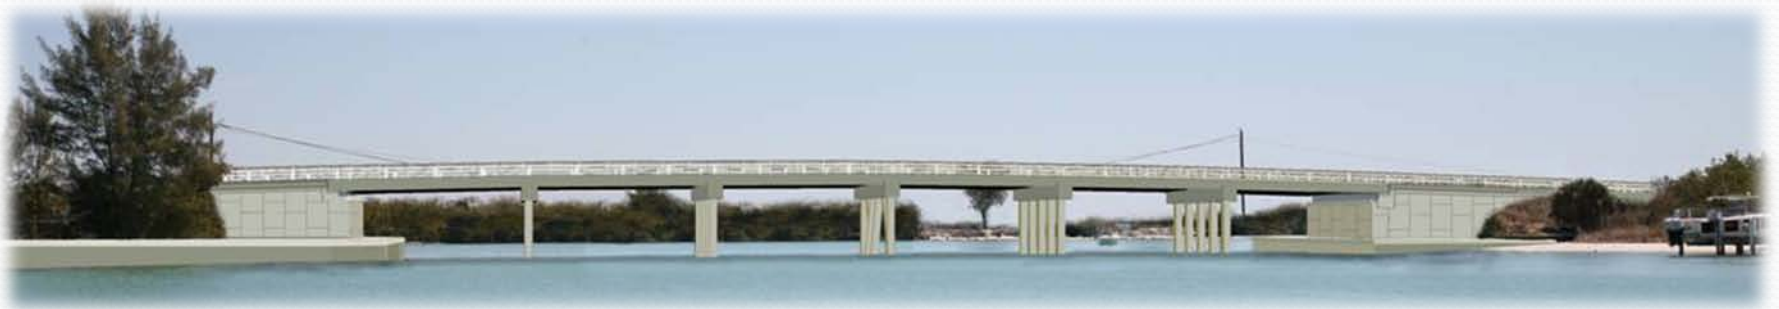
Proposed vertical clearance = 16 feet

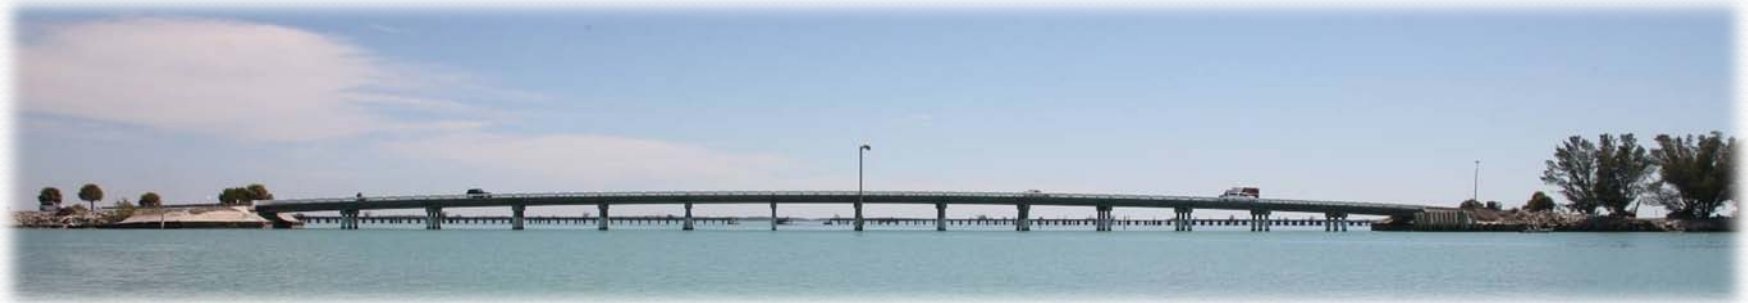
Center Bridge – Existing and Proposed

Existing vertical clearance = 15 feet

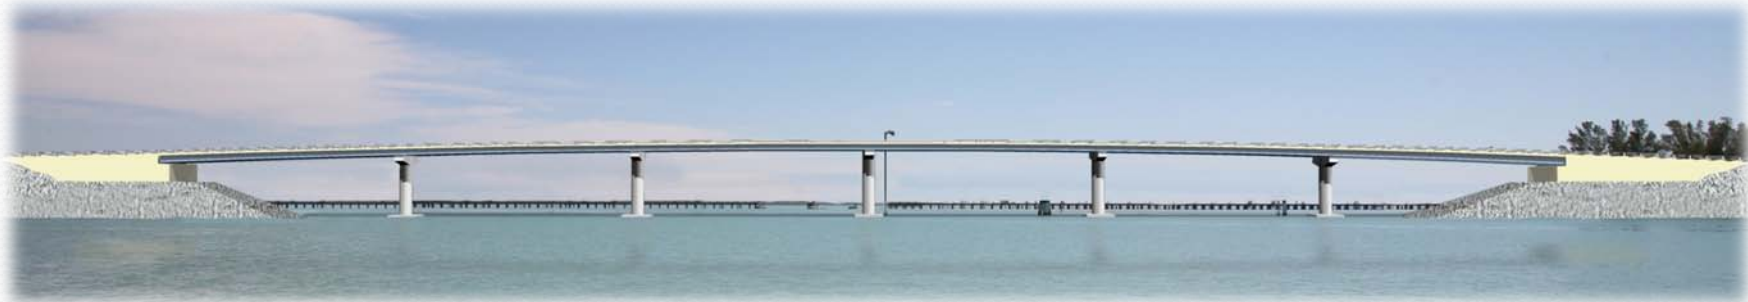
Proposed vertical clearance = 26 feet

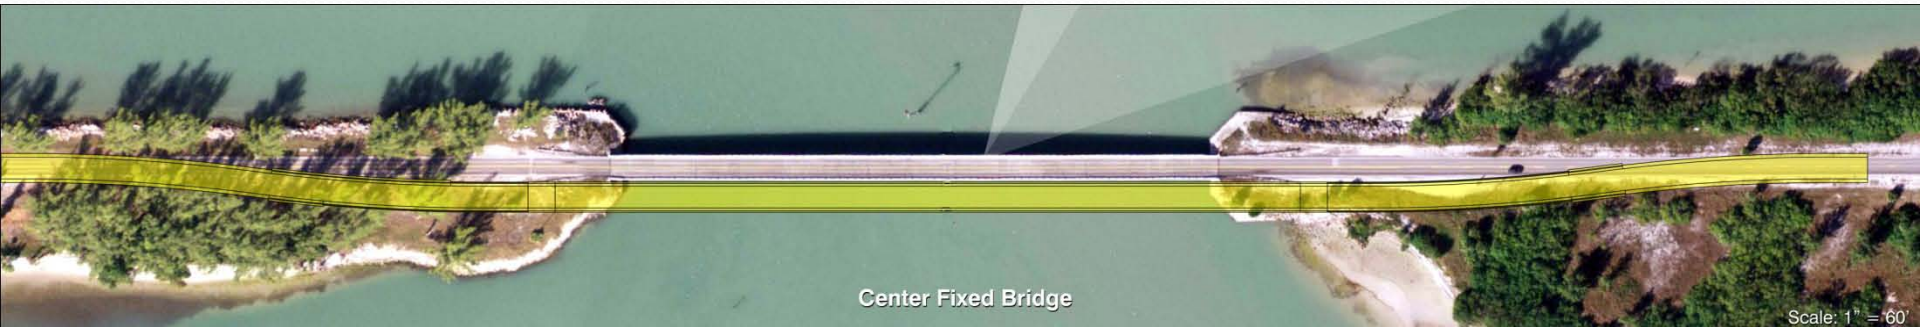
Sequence of Construction – Center Bridge

Center Fixed Bridge

Scale: 1" = 60'
